Case Study

Apartment Block

City of Andoain, SPAIN
Built by Construcciones Moyua,
San Sebastian

Surface: White Carrara Marble Product: STAIN-PROOF™

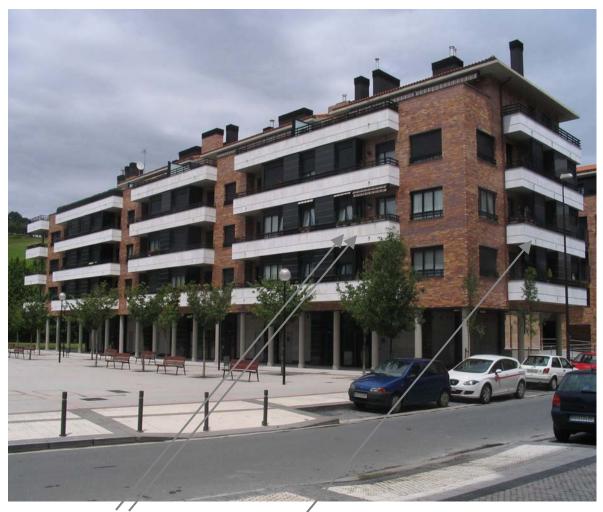
1) Rain water was penetrating into the marble, particularly in the joints where it could collect and sit for extended periods. Marble is a dense stone, but water will move freely through any untreated porous material, just more slowly through dense ones. In this case, the water was passing through the marble and into the structure of the

- building, through walls and floors, leading to a serious damp problem inside the apartments.
- 2) The water traveling through the marble was causing pyrite (iron) deposits within the marble to oxidize (rust) and stain the marble.

Oxidation stains. Water circulating inside the marble was causing microscopic metal deposits within the stone to rust. The rust coloured water was then circulating through the material and running down the outside, leaving these brown vertical marks behind.

Dry-Treat STAIN-PROOF™ was applied to the marble, to create a deep water and oil repellent barrier within the marble. Only Dry-Treat's unique impregnating sealers are able to penetrate deep enough to prevent both entry of water into the marble and circulation of water through the material. STAIN-PROOF™ also forms a permanent chemical bond within the material without changing the colour or breathability of the material.

To date there have been no reports of further oxidation and the dampness in the apartments has dissipated. The STAIN-PROOFTM barrier has successfully prevented water from traveling from outside to inside through the porous marble and structural materials.
