# Belgium Home Floor Renovation

**Surface Type:** Natuursteen | **Products Used:** Oxy-Klenza™ & Stain-Proof™ Original |  
**Completed:** 2015

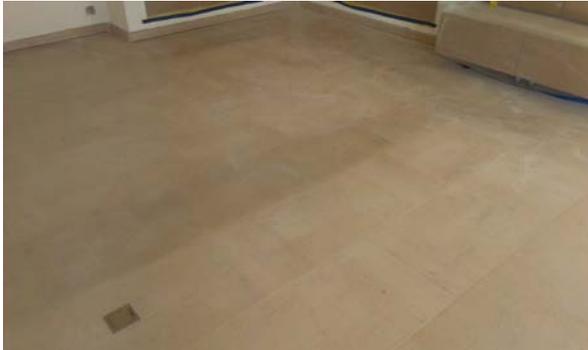
Before

Homeowners in Berchem, a southern district of Antwerp, were renovating their rustic home when they came across a natural stone floor that had been hidden under carpet for years. They decided to remove the carpeting and restore and protect the stone floor.

Miranda and her team at Stone Protection cleaned the floor with Oxy-Klenza and sealed it with Stain-Proof. Due to the heavy amount of residue on the stone, they applied the Oxy-Klenza and allowed it to sit for about 30 minutes. The stains were then removed with the help of a floor scrubber.

After the stone was clean, they applied Stain-Proof to protect the newly remerged stone floor from stains as well as make it easier to clean. Miranda suggested to the homeowners that they use Rejuvenata Active for their regular cleaning.

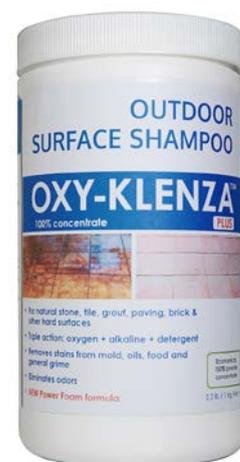
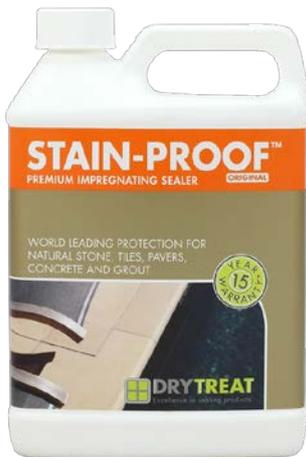
- Removal of existing stains
- Safe to use on natural stone
- Heavy duty to remove general grime and stains caused by oil/grease, food, and beverages
