Dry-Treat 40SK Sealer Evaluation

- Determination of impact on durability when applied to limestone

Our reference: DRT0512-1 Part 4

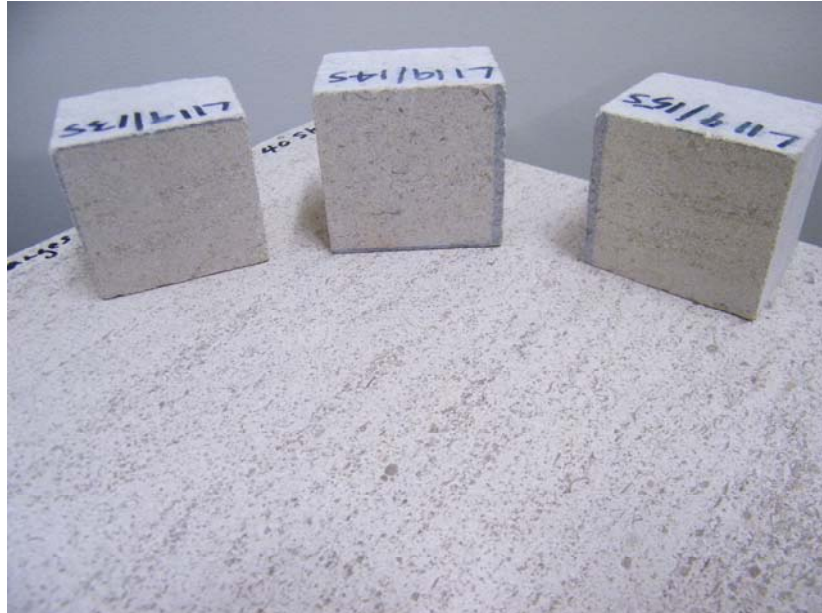
The appearance of the specimens treated with 40SK after the salt attack test compared to the original treated surface is shown in Plate 1 below with no significant change in tonality (after washing to remove salt deposits).

Plate 1: Appearance of Valanges limestone specimens treated with 40SK after the resistance to salt attack test. Specimens are compared with original finish of Valanges treated with 40SK.

The testing carried out shows a marked reduction in decay on the specimens treated with 40SK with only a very slight surface pitting present. The application of 40SK has reduced the weight loss by 99% indicating a dramatic increase in durability against salt crystallization and similar mechanisms such as freeze-thaw.
