# Case Study

## Kilhorne Parish Church, North Ireland.

Surface material: Indigenous Mourne Granite

Sealer: DRY-TREAT STAIN-PROOF™

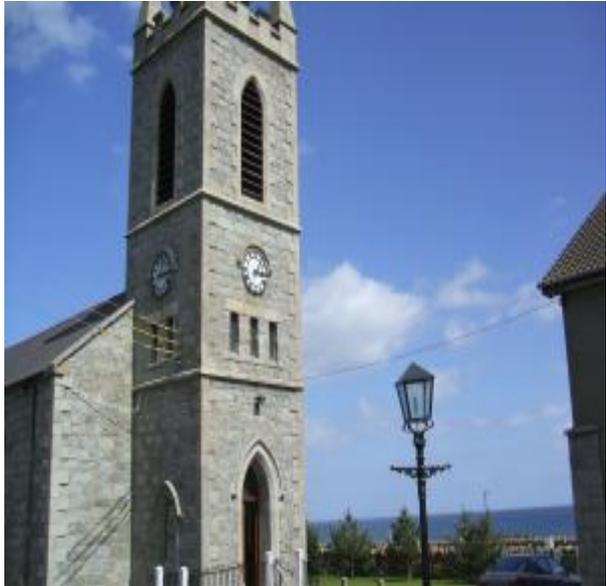
Since this time, there has been evidence of serious water ingress and further deterioration to both the exterior and interior of the church. The building's proximity to the sea meant that the exposed granite was under constant threat of further deterioration if left untreated. To prevent further damage the entire exterior of the church was treated with DRY-TREAT STAIN-PROOF™.

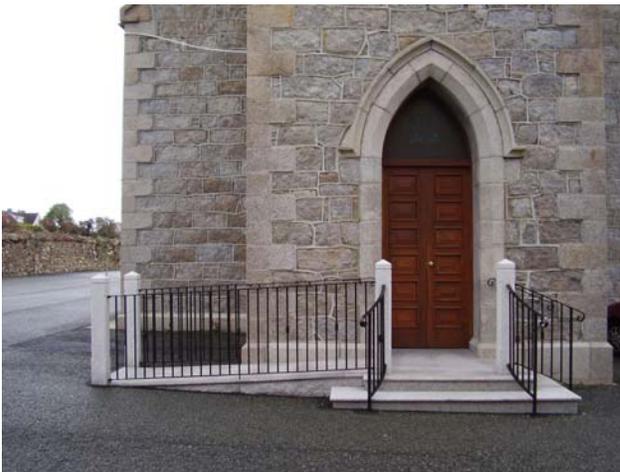
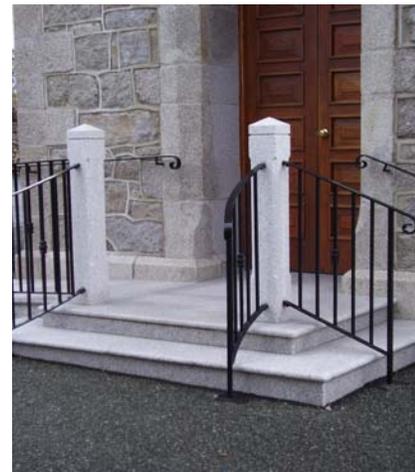
Only 20 years after an official restoration of the Church, officials became concerned with the amount of damage the recently restored church was experiencing. To halt further damage and help maintain the structural integrity of the building, the entire exterior of the church was sprayed with 2 coats of STAIN-PROOF™.
