## SOVEREIGN ISLE

Exterior wall: Schist from New  
Zealand

Product: STAIN-PROOF™

Project Completed: 2009

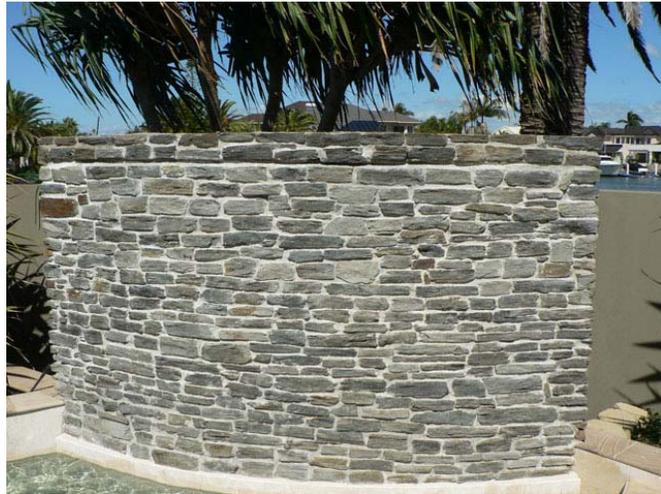
After only two years, the unsealed New-Zealand schist stone showed extensive yellow-brown patches of oxidation (rust) and white patches of salt- efflorescence.

Both conditions were caused by water being able to move freely through the material. Water carries dissolved minerals which can be deposited on the surface when the water evaporates. If the stone contains metal oxide deposits (as in this case) the water speeds up oxidization of these deposits, causing the rapid appearance of rust stains. The owners wanted the staining and salt deposits removed, but were also looking for long term protection to help prevent these problems from quickly returning.

Australia Blue Pty Ltd specialist deep pore cleansing expertise was able to remove the existing staining, after which they applied 2 coats of STAIN-PROOF™. By creating a deep dry barrier, STAIN-PROOF™ will continue to protect against future salt efflorescence, and dramatically slow down oxidization of the metal deposits in the stone. The presence of air (oxygen) will still cause oxidization, but without the presence of water this process will be dramatically slowed, taking many years instead of mere months to occur.
