# Puget Sound Residence, Seattle

**Surface Type:** Chinese Sandstone | **Products Used:** Oxy-Klenza, 40SK, & Stain-Proof Original | **Completed:** July 2016

**Accredited Applicator:** Seal Team One | **Email:** [denny@sealteamone.net](mailto:denny@sealteamone.net) | **Website:** [www.sealteamone.net](http://www.sealteamone.net)

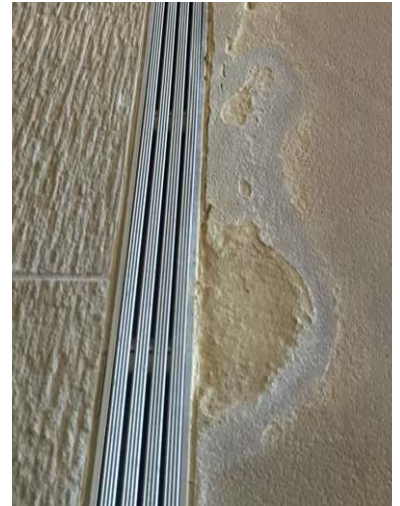
A certain residence on the coast of the Sound has subjected to the harsh marine environment to the point where their Chinese Sandstone patio and veneer were spalling and delaminating within 5 years of installation. Also, dirt and oil staining were prevalent throughout the patio.
