# Brick Residence in Heusden-Zolder, Belgium

**Surface Type:** Brick | **Products Used:** STAIN-PROOF Original™ | **Completed:** June 2014

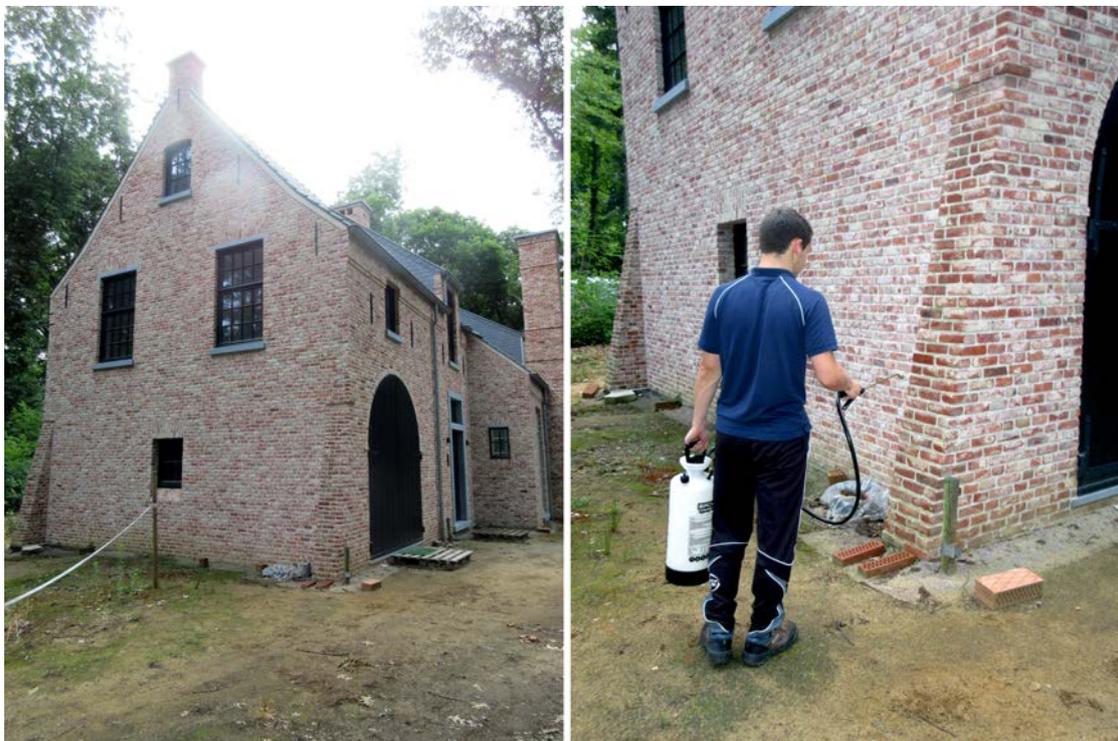
The homeowner chose not to seal the entire house but to seal only the areas exposed to driving rain, namely the façade, rear, chimney, and angled cuts. Stain-Proof was applied to the upper sections of the house using a tall ladder and long sprayer. The application to the lower sections of the house was applied using a low-pressure nozzle.
